Morphodynamic responses of nourished beaches in SW Spain

Anfuso, G.; Benavente, J. & Gracia, F.J.*

Dept. of Geology, Faculty of Marine Sciences, University of Cádiz, 11510 Puerto Real, Cádiz, Spain;

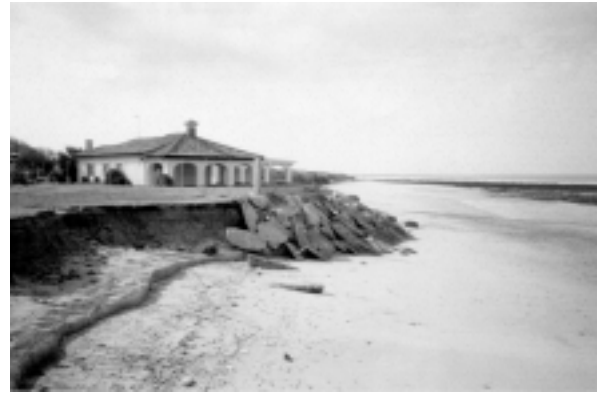
Fig. 2. Erosion problems near Punta Candor. The Quaternary cliff is eroded and summer houses are protected by a rip-rap revetment.

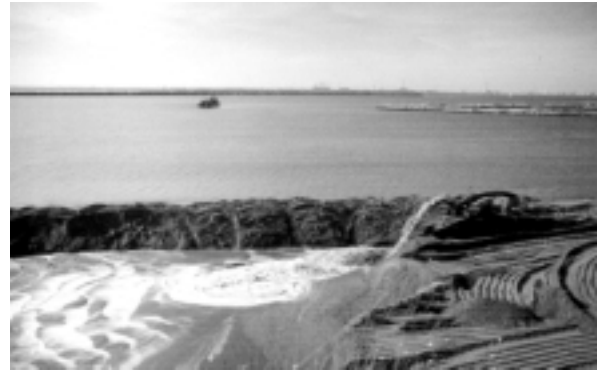
Fig. 3. Nourishment works on Aculadero beach, with the pipeline pumping sediment on to the beach. Note the dredging boat in the background.

In all cases the sand was dredged from the Cádiz harbour channel, at water depths between 8 and 14 m, and then pumped onto the beach through a short floating pipeline. The sediment was spilt on the back-shore and in the upper part of the foreshore to widen the visible beach (Fig. 3). Bulldozers were then used to reshape the back-beach to create raised, flat, berms, characterized by an important seaward slope and a narrow foreshore. By this procedure the initial dissipative profile was transformed into a fully reflective one.

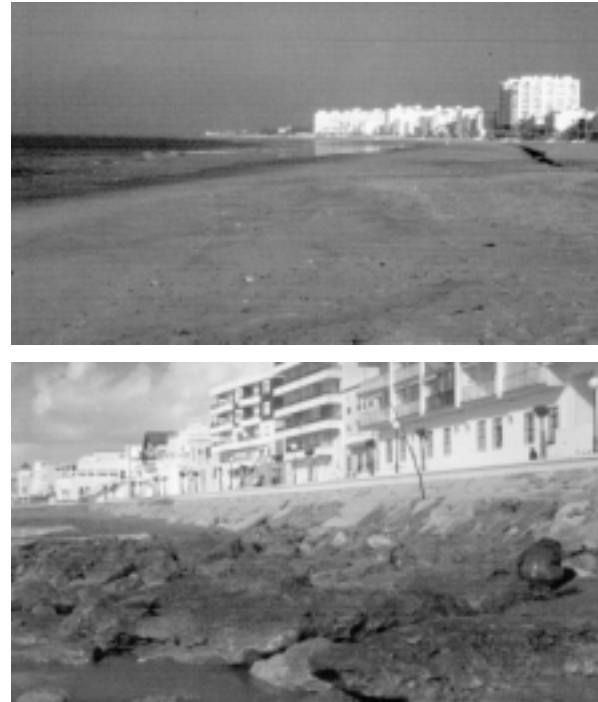
Fig. 4. Rota beach in October 1996, after the nourishment works (a); the same beach after a heavy storm in December 1996, outcropping the rocky substratum (b).

The restored profile had a reflective slope with a narrow intertidal area (Figs. 4a and 5a). In October 1996 a small storm eroded the berm along the whole restored beach length and generated a 70 cm high bluff: 22% of the filled sand was lost. A second storm, in November, caused further erosion and the beach acquired a slope quite close to the initial one. Maximum erosion (130% of the filled sand) was recorded in December, when a third severe storm flattened the beach and the rocky substratum cropped out (Fig. 4b). Under fair weather conditions the beach progressively recovered only a small part of the eroded sand. In March 1997, small volumes of sand were spilt again in the back-shore and in the upper and middle parts of the foreshore. A new equilibrium was reached in the following months and in October 1997 a certain recovery was observed, although most of the nourished sand had been lost. In March 1998 the beach showed a reflective profile quite similar to the one observed the previous summer.

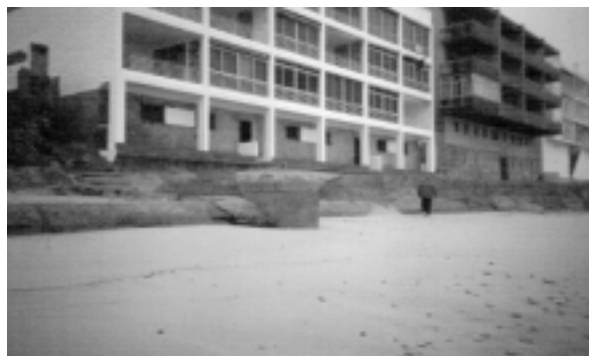
Fig. 6. A beach scarp generated on the Fuentebavía beach by the storm of December 1996.

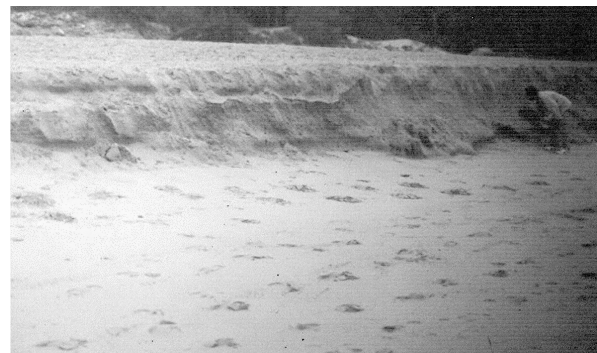
Fig. 7. A pronounced beach scarp (> 1 m) generated at Aculadero beach during a storm in November 1995.

After the storm period autumn 1995/winter 1996, the central part of the beach almost completely disappeared (Fig. 7). In May 1996 the beach contained only a small amount of sand on the upper foreshore, restricted to the cliff toe and showed a dissipative profile. In front of this the rocky shore platform cropped out for some 50 m. The nourishment works gave rise to a reflective artificial beach upon the rocky substratum. During the autumn of 1996 and the winter of 1997, the beach was greatly affected by erosive processes, and no recovery was recorded during the following spring and summer periods (Fig. 5c). During the summer of 1998, no variations were observed and the rocky substratum still cropped out.
